Soil Science & Basin Restorations

Rebecca Hodges

USDA-NRCS

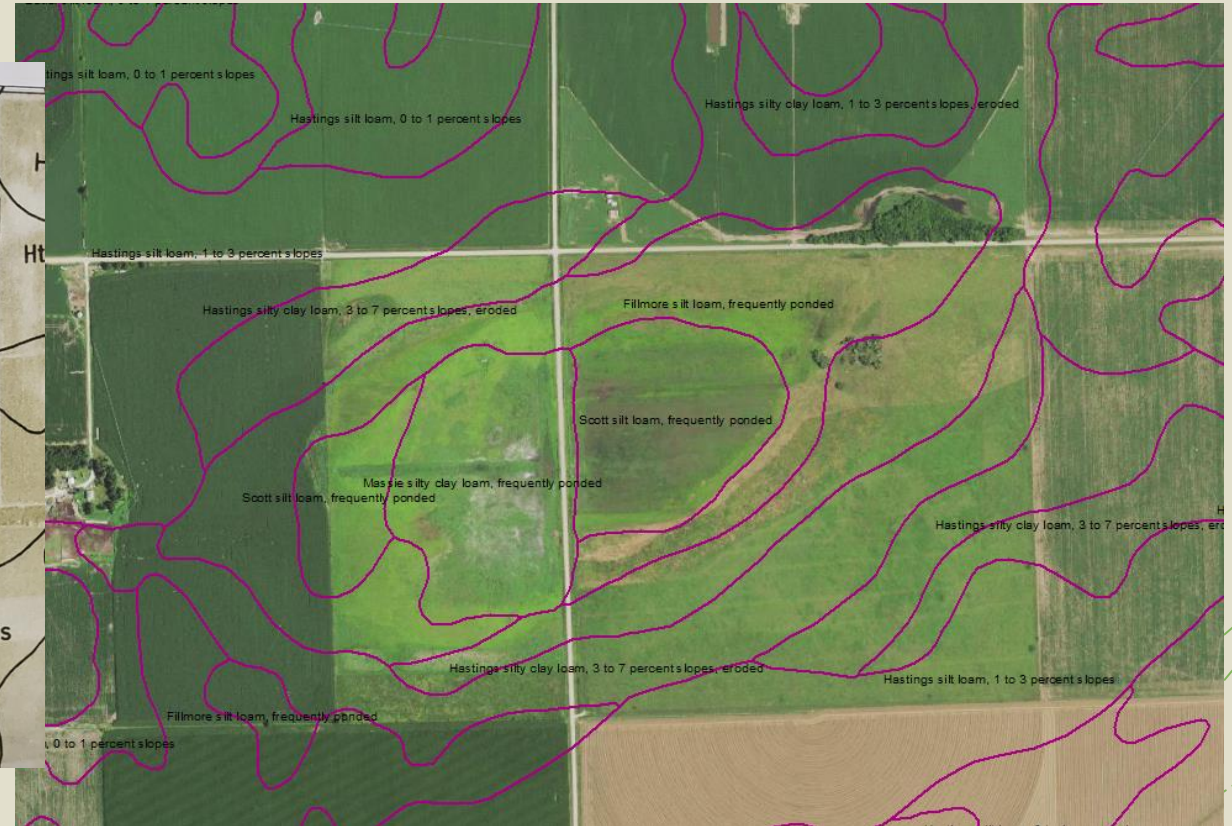
OSD

SCOTT SERIES

The Scott series consists of very deep, poorly and very poorly drained soils that formed in loess. Scott soils are in closed depressions on loess uplands and stream terraces in the Central Loess Plains, MLRA 75. Slopes range from 0 to 1 percent. Mean annual precipitation is about 635 millimeters (25 inches) and the mean annual temperature is about 11 degrees C. (51 degrees F).

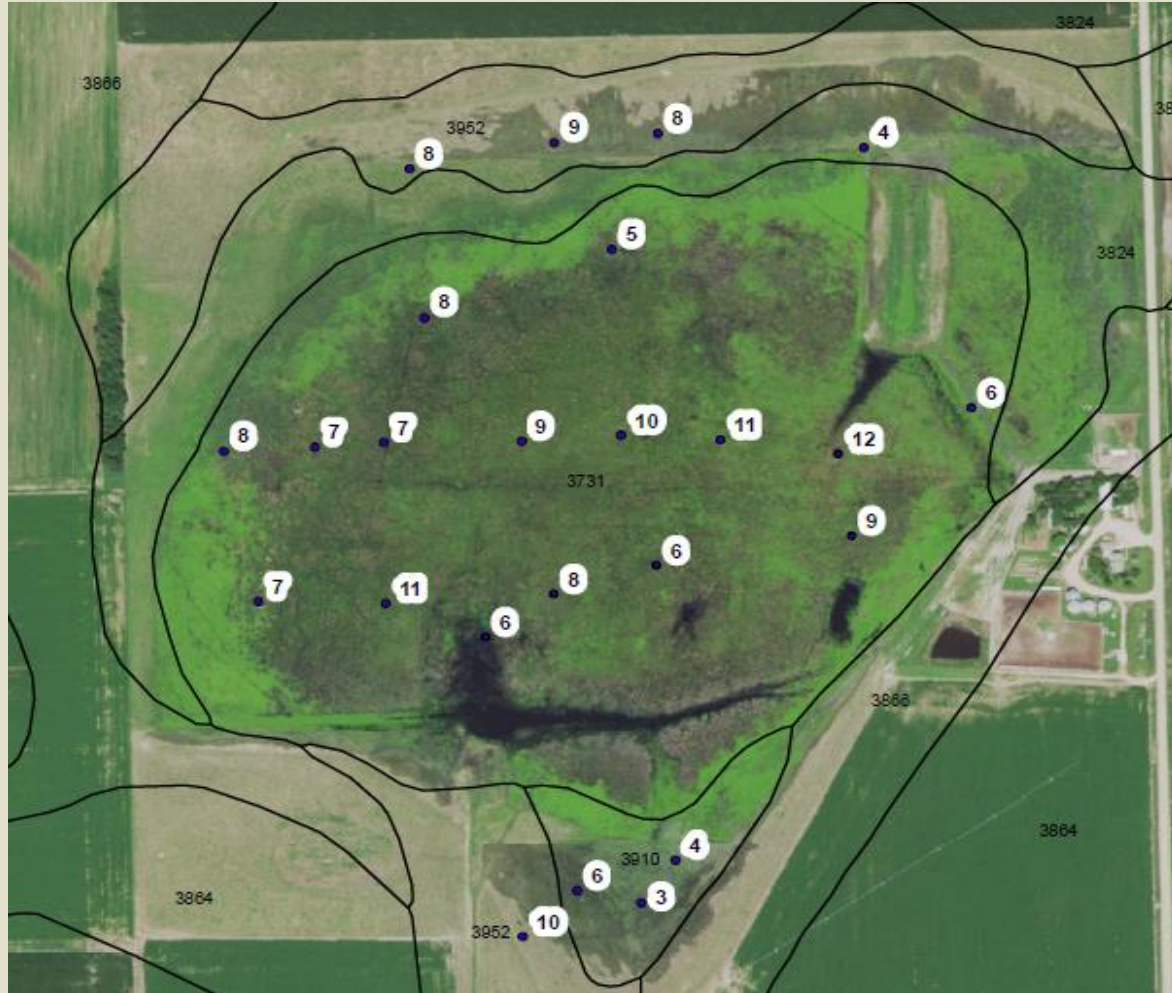
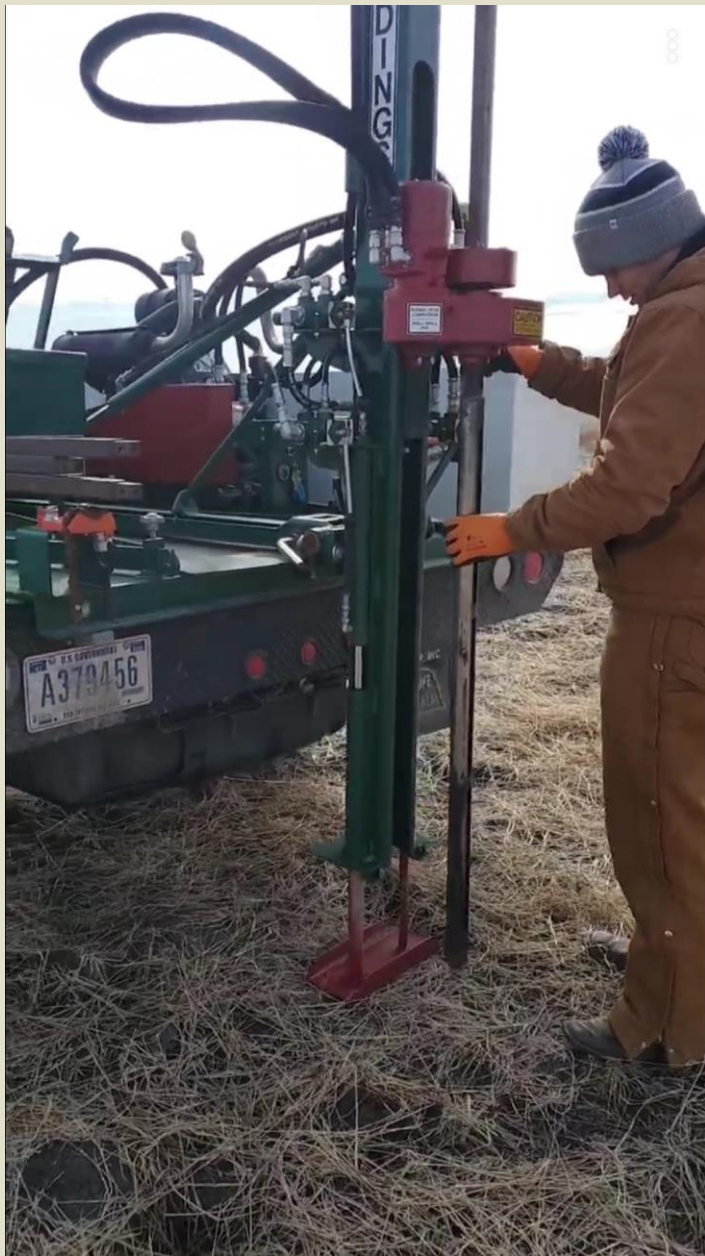
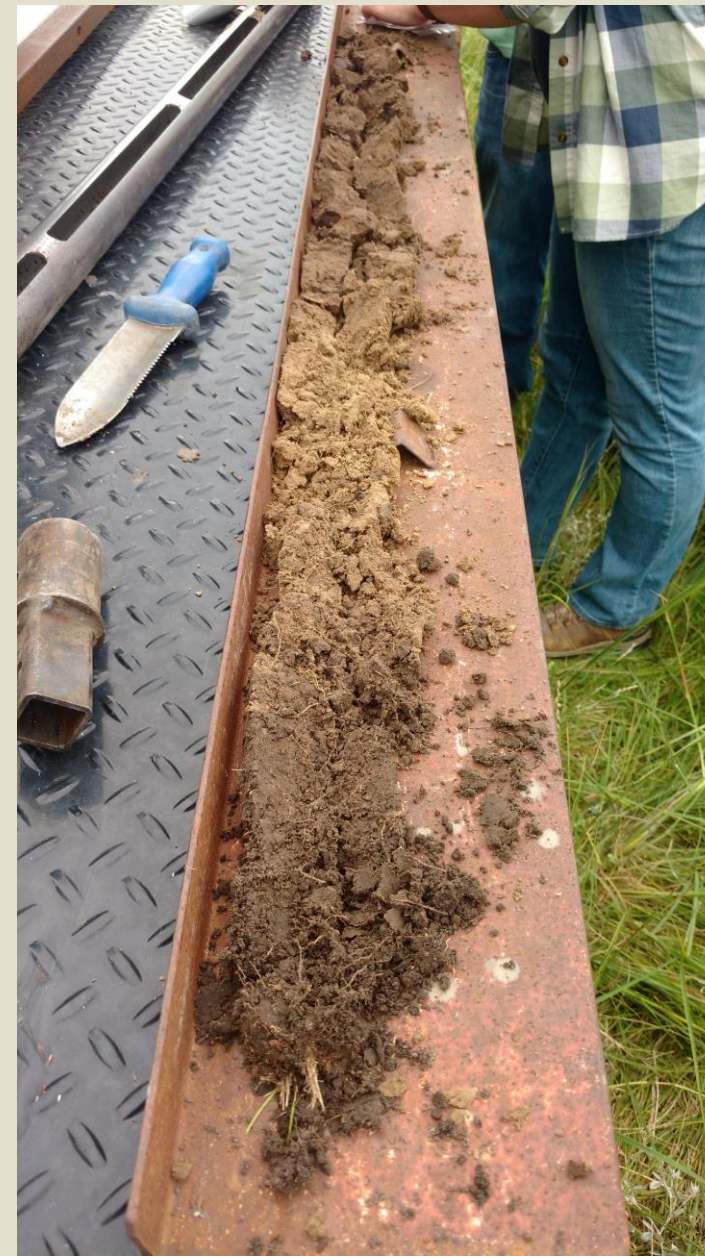
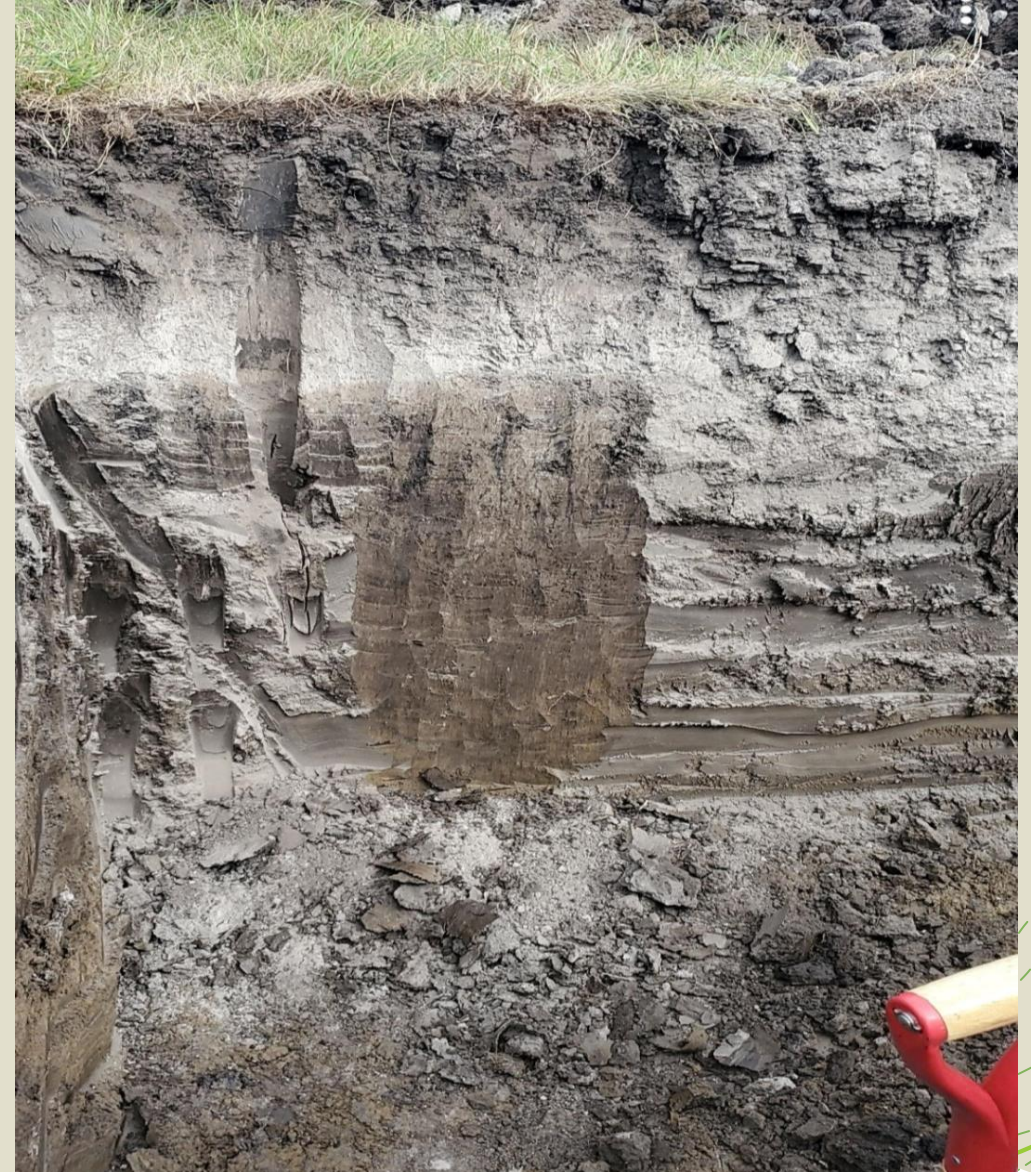
Transect, Describe, Report

This site is mapped as a Scott with a Hord boundary. Onsite soils investigation would suggest this site is more like a Fillmore soil type in most areas. First noted manipulation on this site was observed in 1958 by installation of reuse/drainage pit. This manipulation shrunk the wetland footprint by about 5.5 acres. Reuse/drainage pit was increased in size in 2010. This manipulation shrunk the existing wetland size by about .5 acre.

The soil survey concluded there is a normal A horizon and intact E horizon through the majority of the wetland footprint. Average depth of the A horizon was around 9-13", some outliers being deeper. Most E horizons were 3-4" thick. Depth to the Bt1 horizon resembled a soil more typic of Fillmore, than Scott. There is approximately 1" of vegetative build up (organic matter) on top of the soil surface throughout the site. No excess sediment was found in the cores described. Lidar indicates a berm around the pit. No cores were sampled there. Combining the soils data with the topo survey should confirm enough borrow to fill the pit.

Hodges Recommendation: The ideal restoration on this site would include filling the pit and controlling the invasive species: reed canarygrass and cattail.
